| 2. Random Vibration Operation Test --- | 3 |
| 3. Random Vibration Non-Operation Test --- | 4 |

Test Product: FWS-825 (FWB-880N A0.2)

Test Standard: Reference IEC68-2-64 Testing procedures
Test Fh : Vibration boardband random test

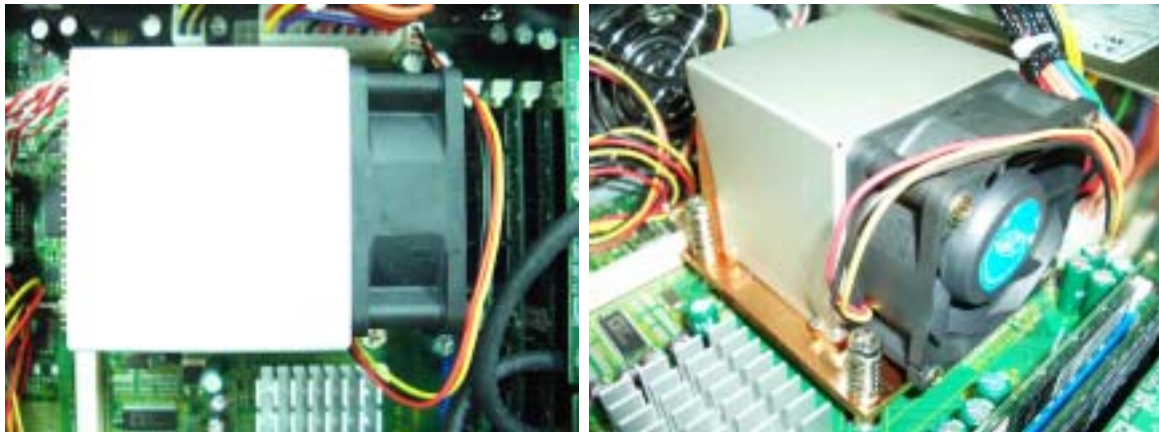
CPU Cooler

Num	Item	Spec
1.	Control Box:	FWS-825 / 2U 6 LAN Port Rack Mount Firewall Chassis
	1. Main Board	AAEON FWS-880N A0.2 (BIOS: 1.0)
	2. CPU	Intel Pentium 4 / 3.8GHz (FSB: 800)
	3. Memory	1GB Kingmax ELPIDA E5108AB-5C-E (DDR2-533) * 2 1GB Kingmax Hynix HY5PS12821 F-C4 (DDR2-533) * 2
	4. Ethernet Daughterboard	PER-C102 A1.0
	5. Ethernet Daughterboard	PER-C102 A1.0
	6. Ethernet Daughterboard	PER-C102 A1.0
	7. Power Supply	Seventeam ST-352UAG-05E / 350W (ATX)
	8. SATA HDD	Western Digital WD800 / 80GB
